Pythian Powerhouse and Laundry

Historic Building Survey

August 2008

(Building No. 503)

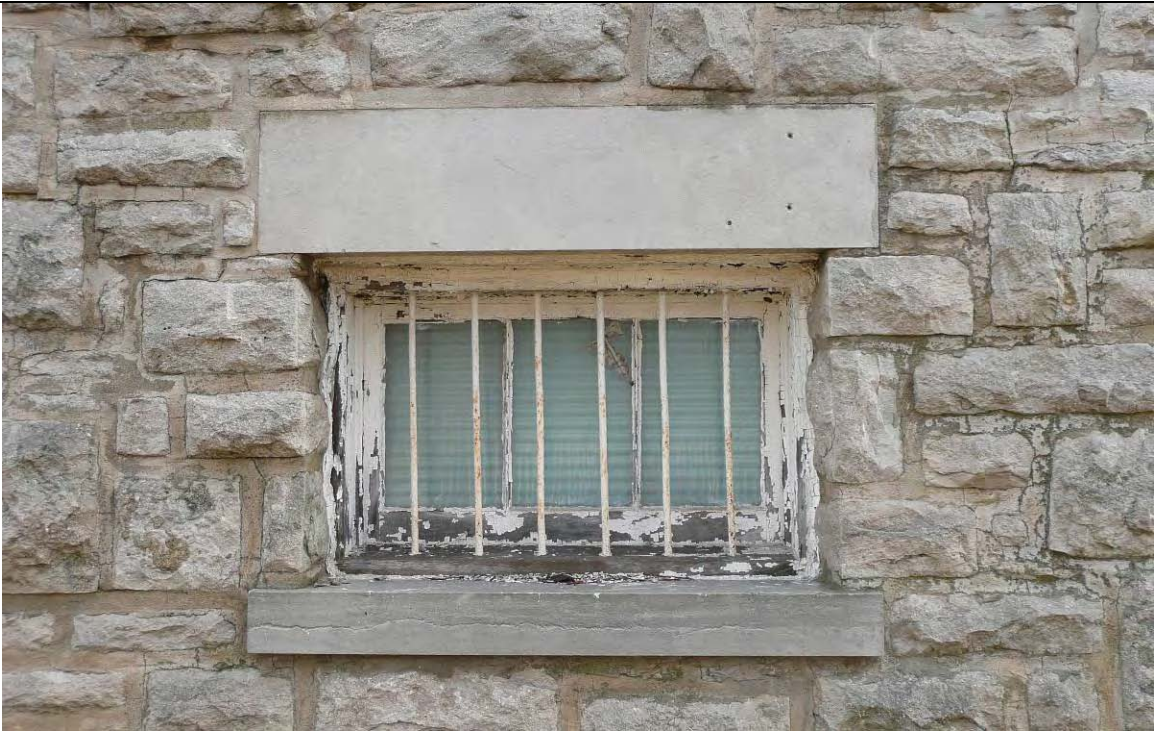
Type 5: Small wood three-pane awning window that measures 3'-8" by 2'-4" (Photo 22).

Photo 23 – Type 5 window

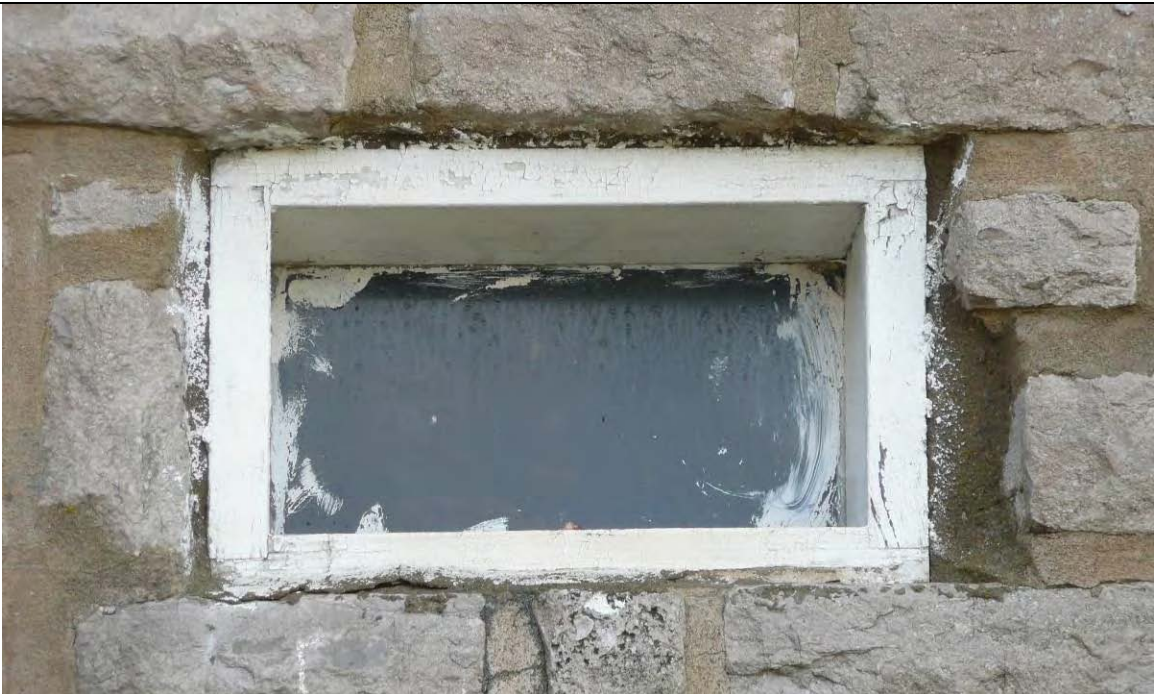
Type 6: Small single-pane wood fixed window that measures 1'-8" by 1'-0" and is framed with 2x4 members (Photo 23).

Photo 24 – Type 6 window

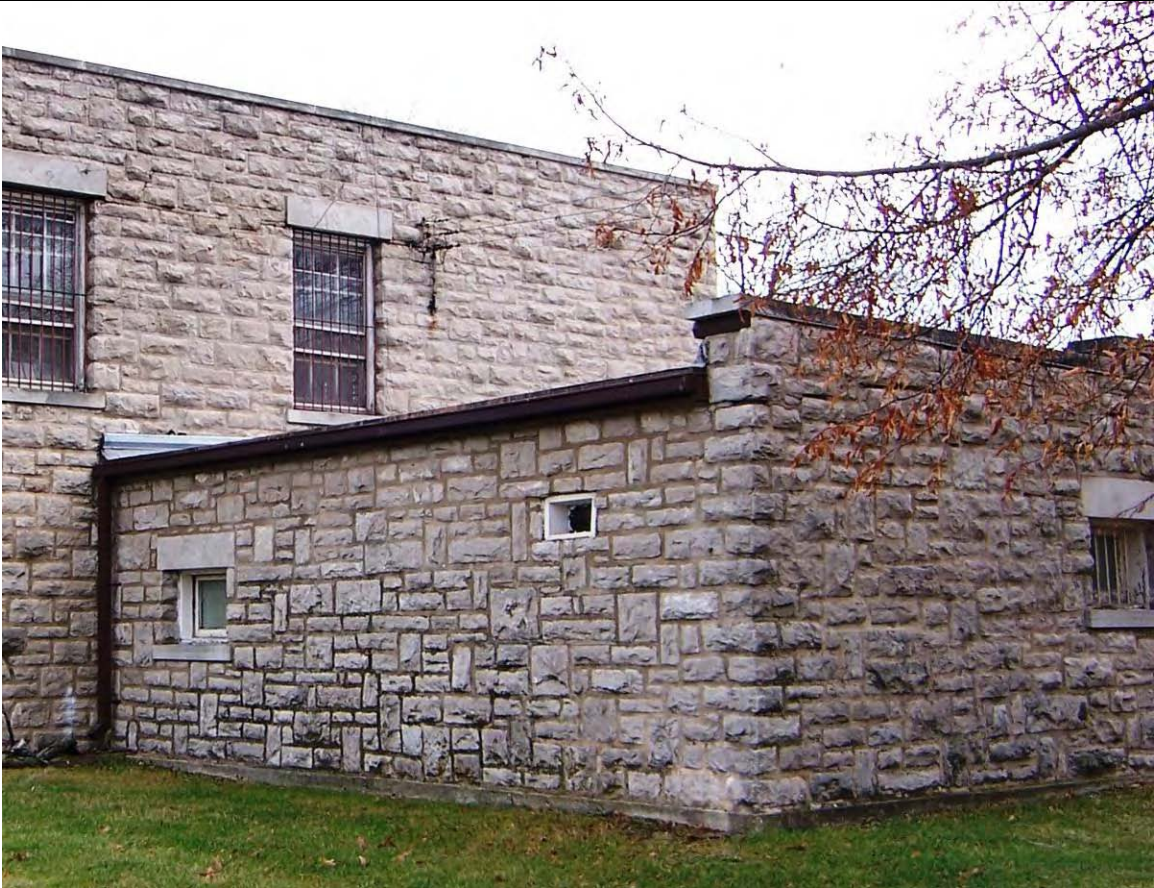
The north elevation (Photo 11) is defined by several window openings. The majority of the elevation is two-stories tall. The first floor of the two-story exterior wall has a window opening modified with one window and a replacement door (Photo 12), one set of paired six-over-six wood double-hung windows, a modified window opening that has been filled in with stone, and one single six-over-six wood double-hung window. The second floor consists of four evenly spaced single six-over-six wood double-hung windows. All of the windows have concrete windowsills and lintels and are covered with metal security bars. The right side of the north elevation is recessed from the two-story portion. The right side is one-story tall and has one smaller three-pane wood awning window with a concrete windowsill and a small single-pane fixed window without a concrete windowsill (Photo 27).

Photo 27 – parapet detail on west elevation of one-story garage

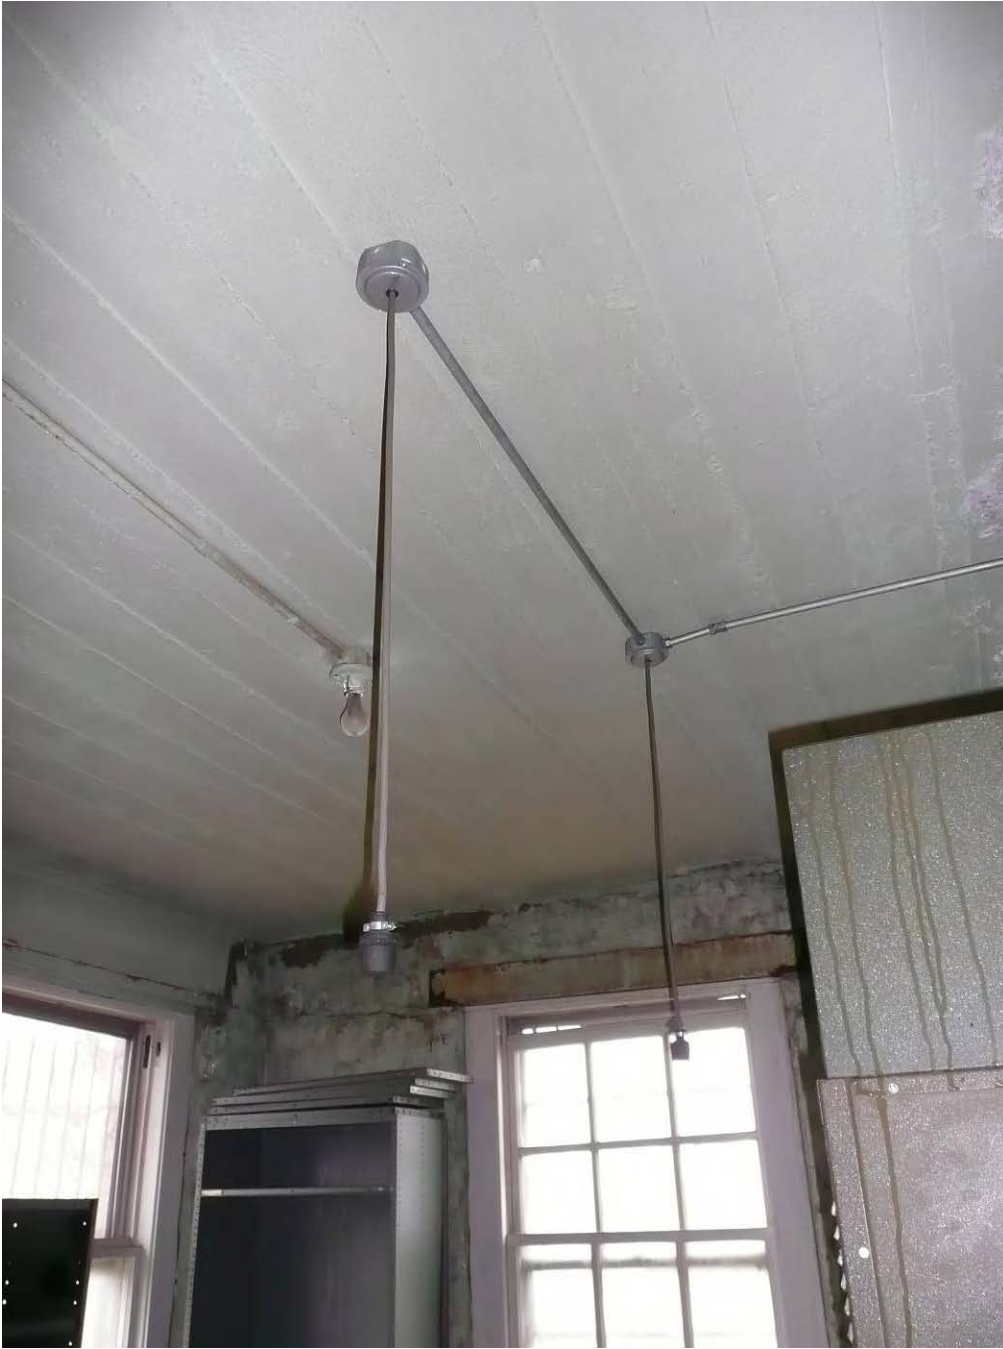
Photo 39 – view of concrete ceiling
